## How to fix poor fit of servo horns on the Corona Servo CS238MG

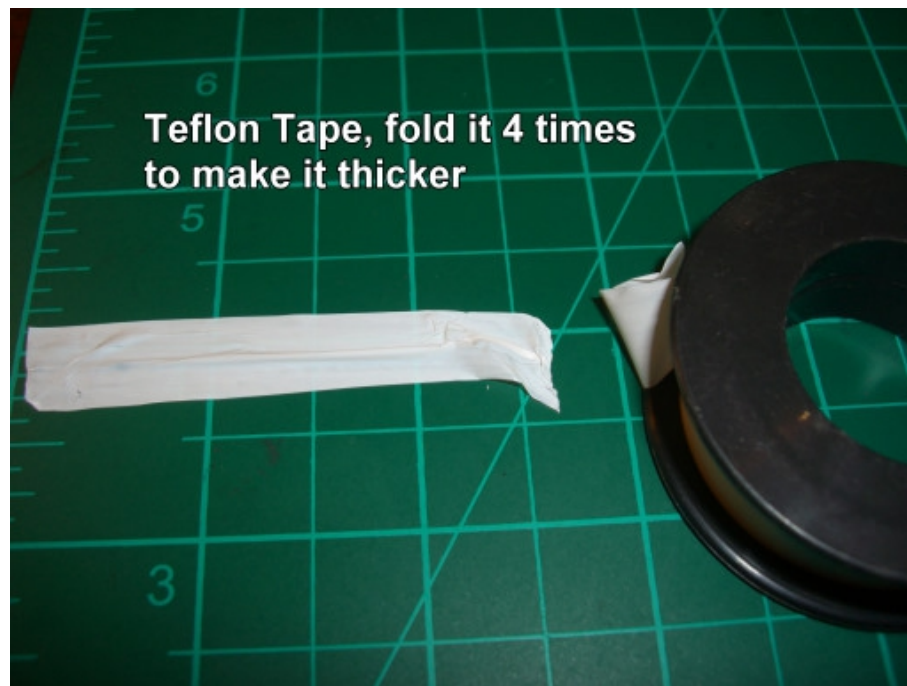
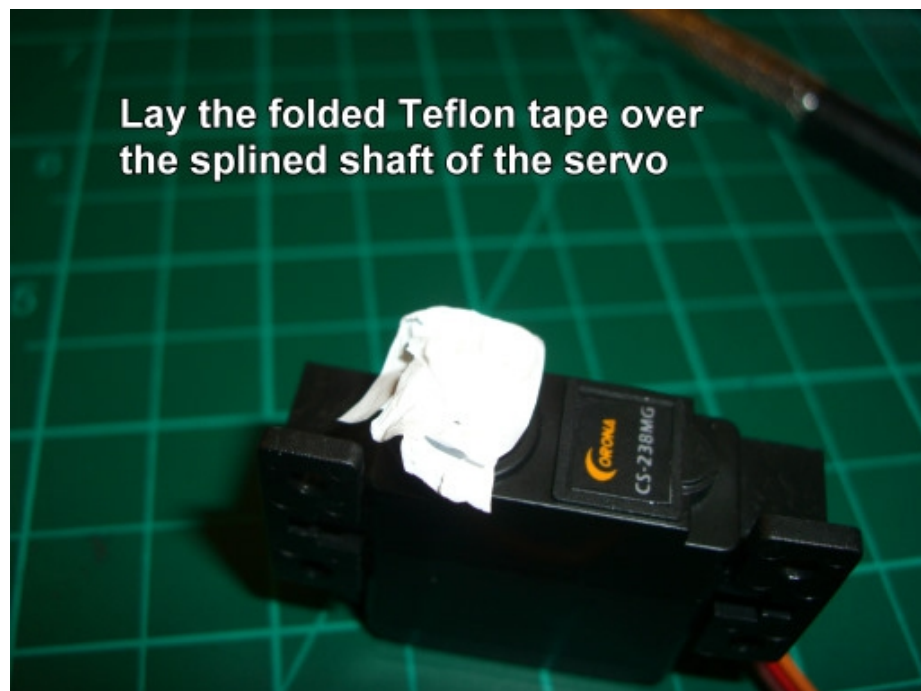
Press the horn over the shaft  
with the tape

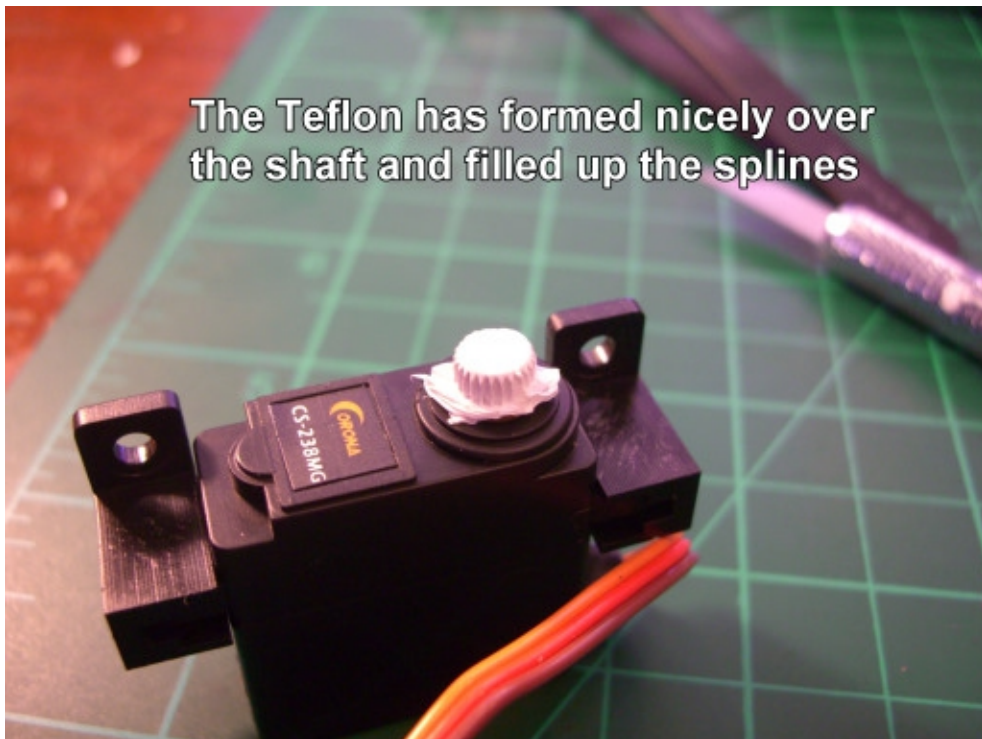
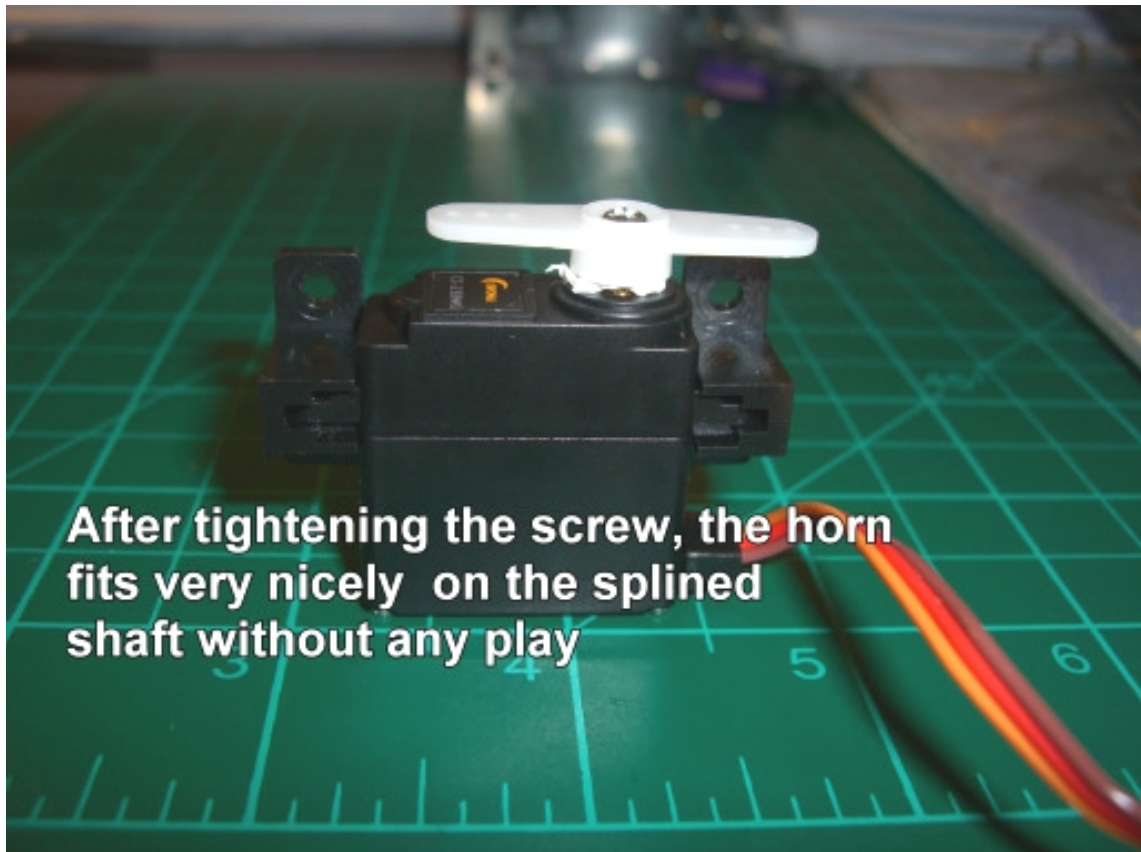
After tightening the screw, the horn fits very nicely on the splined shaft without any play
